Proof of effect of interference from interferometer box 1-2m away from array computer/receiver box causing interference that changes the trace on array computer ezCol collection screen:

13/2/24:

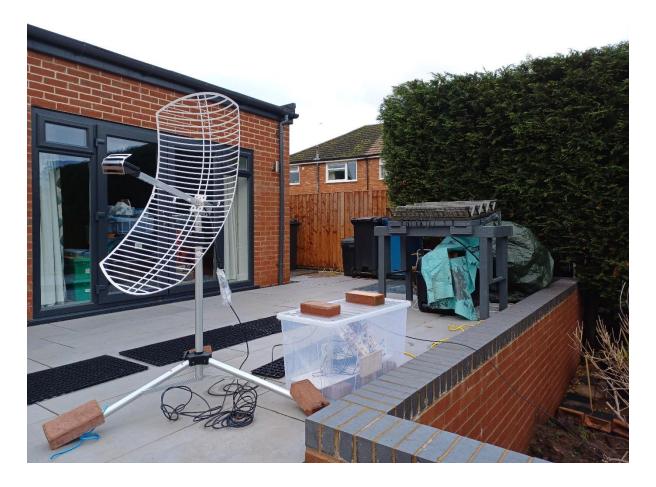
Placement of interferometer computer box (white here) and Pharmigan array computer box (black box covered in green sheet under blue table near conifers at back):

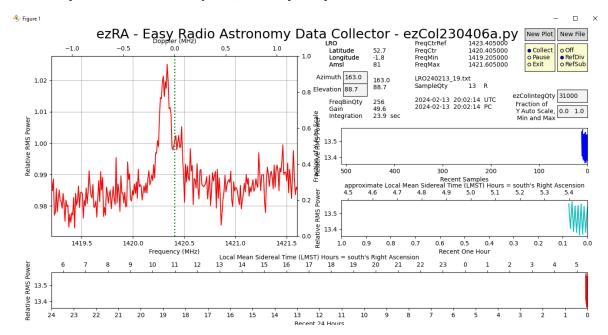
Dehumidifier turned ON in array box, whole of interferometer box switched OFF:

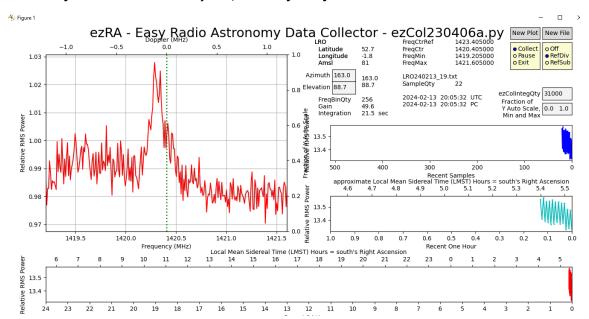
Dehumidifier turned OFF in array box, whole of interferometer box switched OFF:

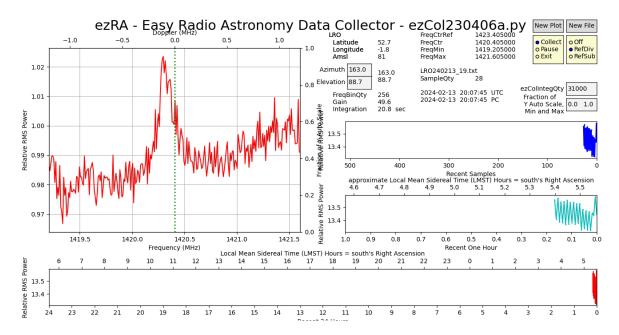
Dehumidifier turned ON in array box, whole of interferometer box switched OFF:

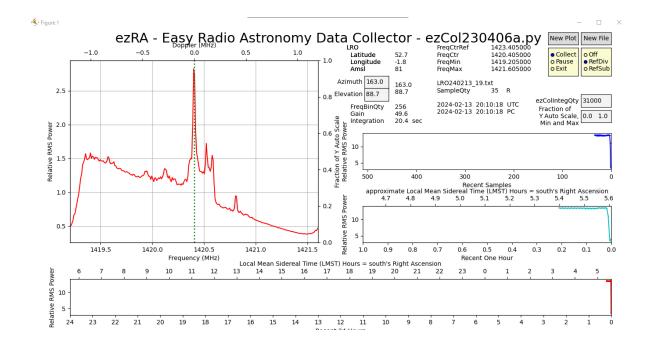
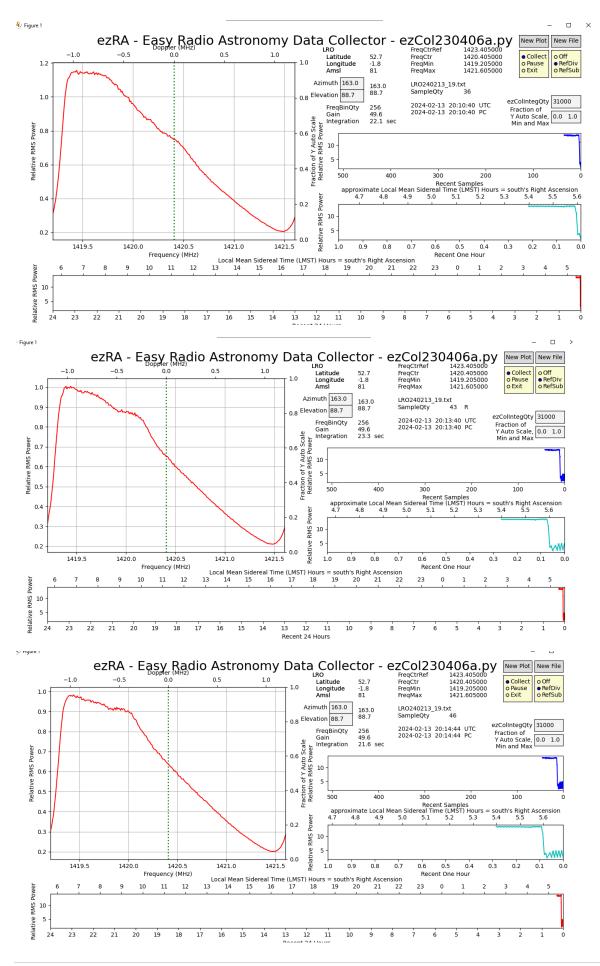
Dehumidifier turned ON in array box, whole of interferometer box switched ON:

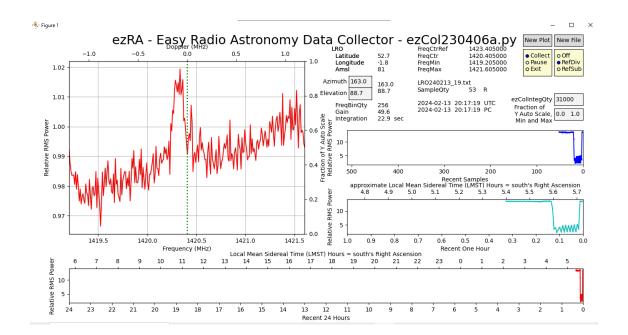
Dehumidifier turned ON in array box, whole of interferometer box switched OFF again:
